INDOOR AIR QUALITY ASSESSMENT

**Manchester Memorial Elementary School
43 Lincoln Street
Manchester, Massachusetts**

Prepared by:
Massachusetts Department of Public Health
Center for Environmental Health
Bureau of Environmental Health Assessment
Emergency Response/Indoor Air Quality Program
September 2004

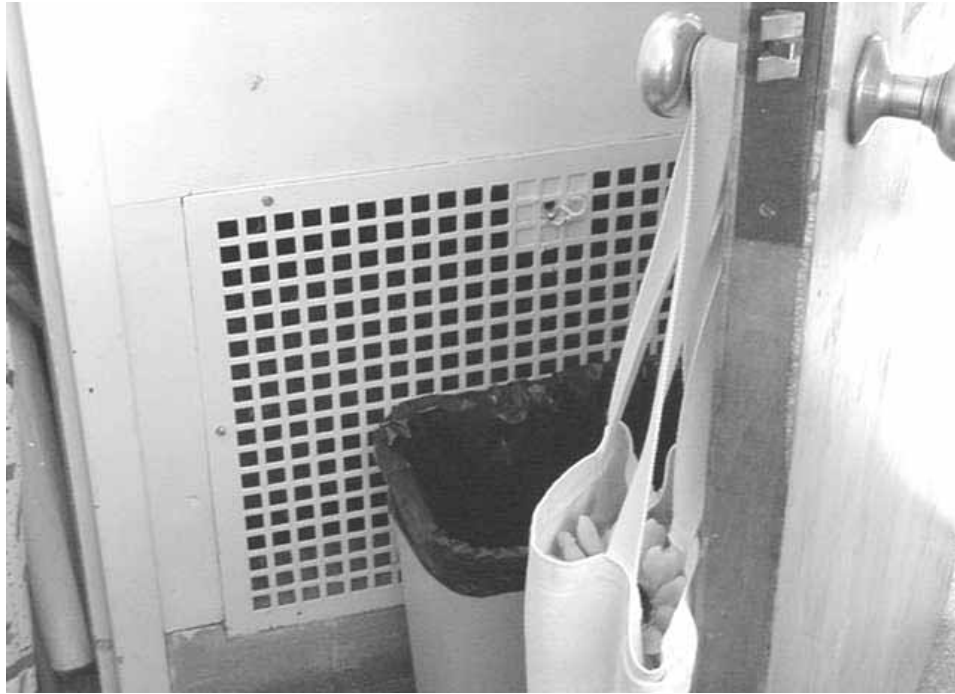
Picture 3

The school has two different types of exhaust ventilation systems. Exhaust ventilation is provided to classrooms in wing A by ducted, grated vents equipped with pull chains that adjust a flue in the ductwork (Picture 3). Some exhausts in wing A are located near hallway doors that can be blocked when doors are open. Exhaust ventilation in the other wings is provided by cabinet-mounted exhaust vents (Picture 4). Motorized fans draw air through grilles on cabinets and direct air below ground through ductwork out of the building via subterranean grates (Picture 5). Exhaust vents were drawing weakly or blocked with materials in a number of classrooms surveyed. As with univents, exhaust vents must be allowed to operate and remain free of obstructions.

Exhaust Ventilation Provided by Ducted, Grated Vents Equipped With Pull Chains to Adjust Flue Located in the Ductwork

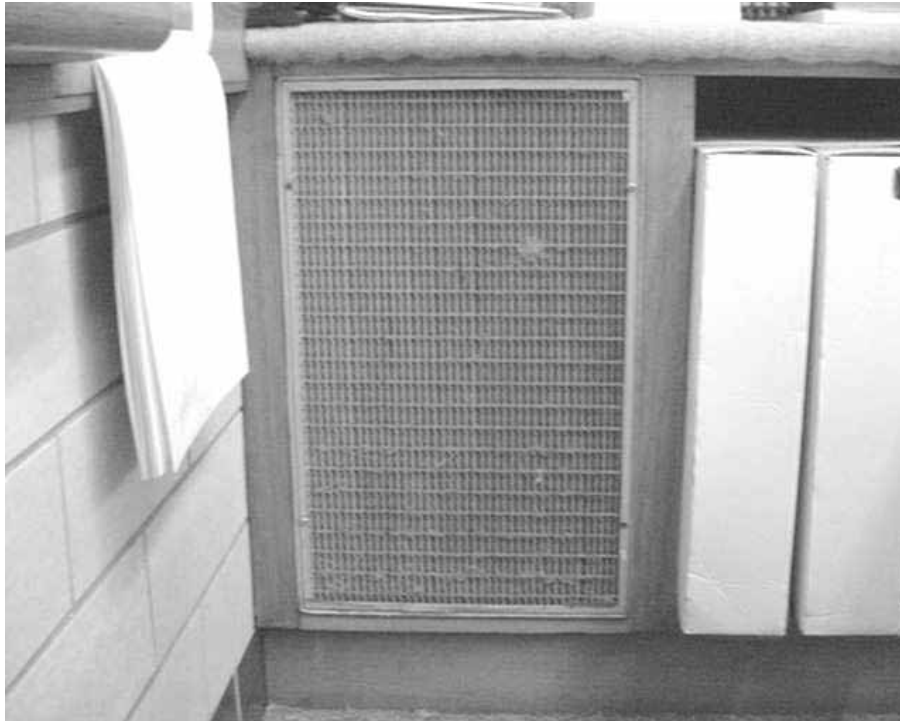
Picture 4

Exhausts Grill Installed in a Cabinet

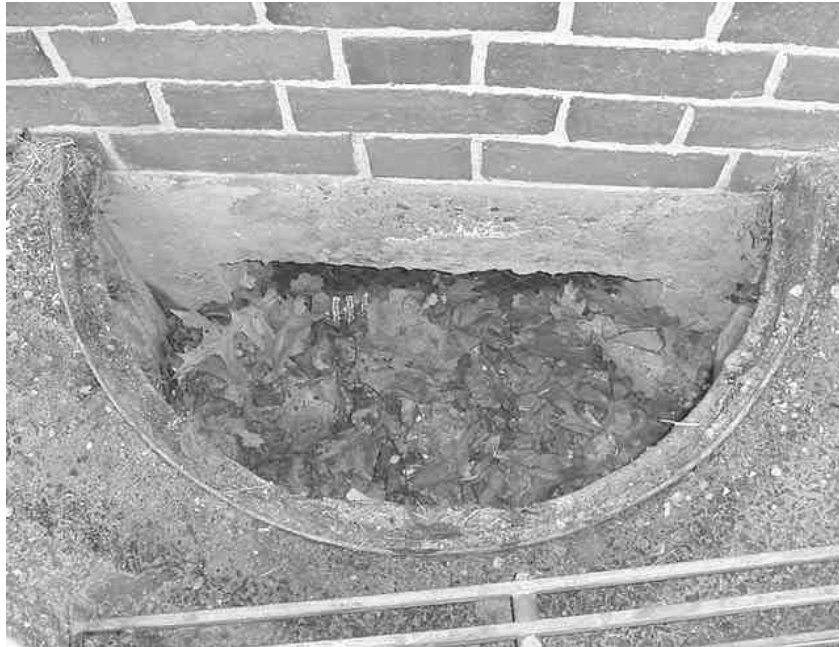
Picture 5

leading to water penetration through the subterranean exhaust vents and/or through exterior classroom doors.

Below Grade Exhaust Vent in a Subterranean Pit

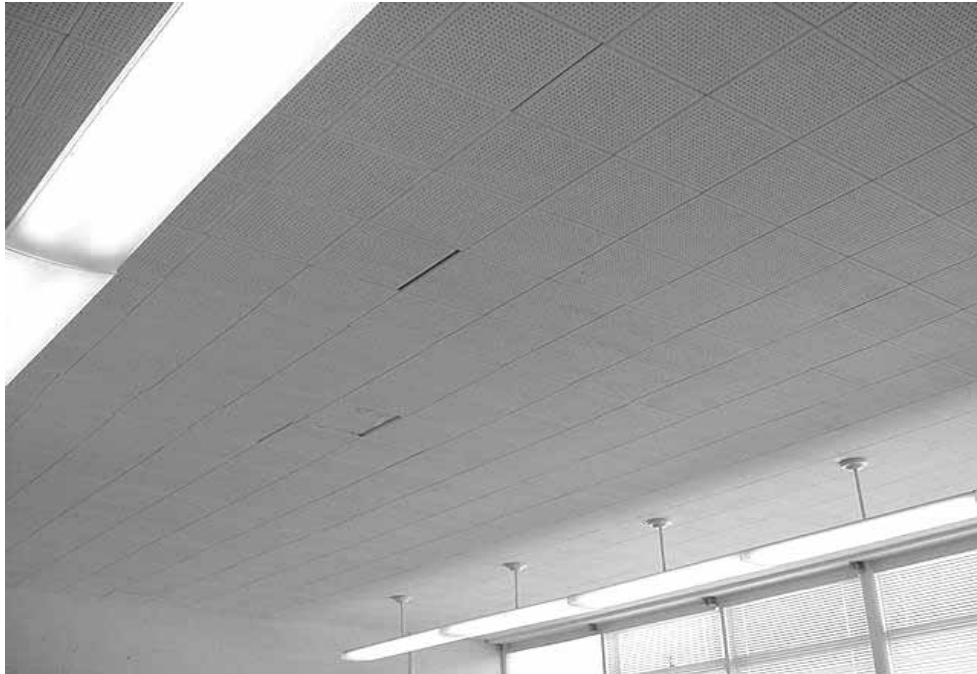
Picture 6

mold growth. Water-damaged ceiling tiles should be replaced after a water leak is discovered and repaired. The school has a ceiling tile system where tiles are glued directly to the ceiling/walls (Picture 6). Replacement of these ceiling tiles is difficult, since their removal appears to necessitate the destruction of the tile. Appropriate measures should be taken to minimize the aerosolization of particulates from tile removal/replacement.

Interlocking Ceiling Tiles

6. Examine the feasibility of installing a gutter/downspout system on the roof.
7. Identify and repair sources of water leaks (e.g., window frames and roof). Replace water-damaged ceiling tiles. These ceiling tiles can be a source of microbial growth. Examine the non-porous surface beneath the removed ceiling tiles and disinfect with an appropriate antimicrobial.

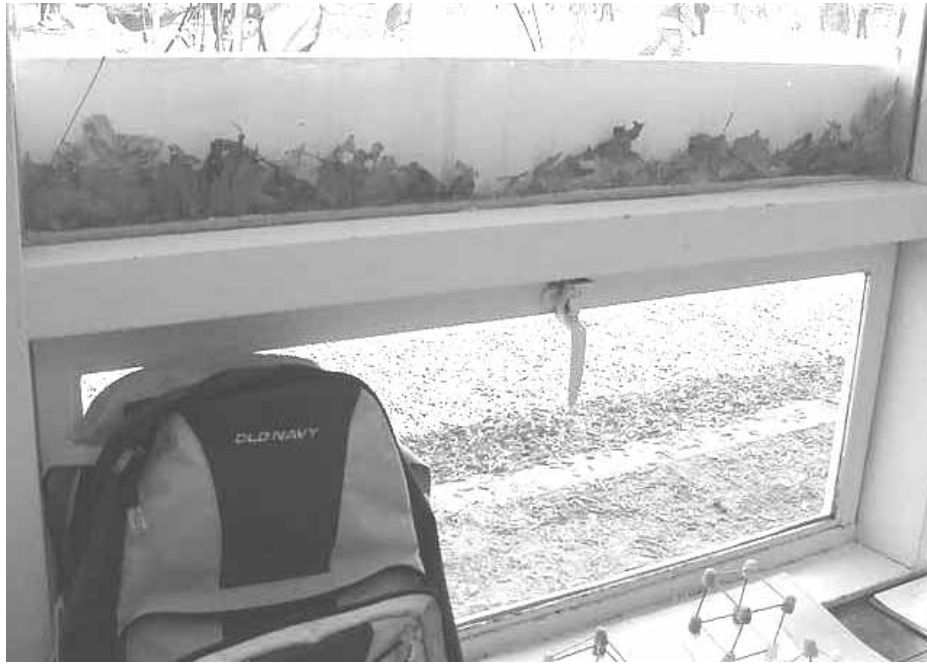
Picture 7

An exit to the playground is located between wings D and E. A protective wood barrier was erected over the hallway window frame in this area. A significant amount of leaves had accumulated between the barrier and window frame (Picture 7). Under certain weather conditions, these leaves can become moistened and hold moisture against the window frame, providing a source for water penetration. In addition, leaves can be a mold growth medium.

A Significant Amount of Leaves Has Accumulated Between the Barrier and Window Frame

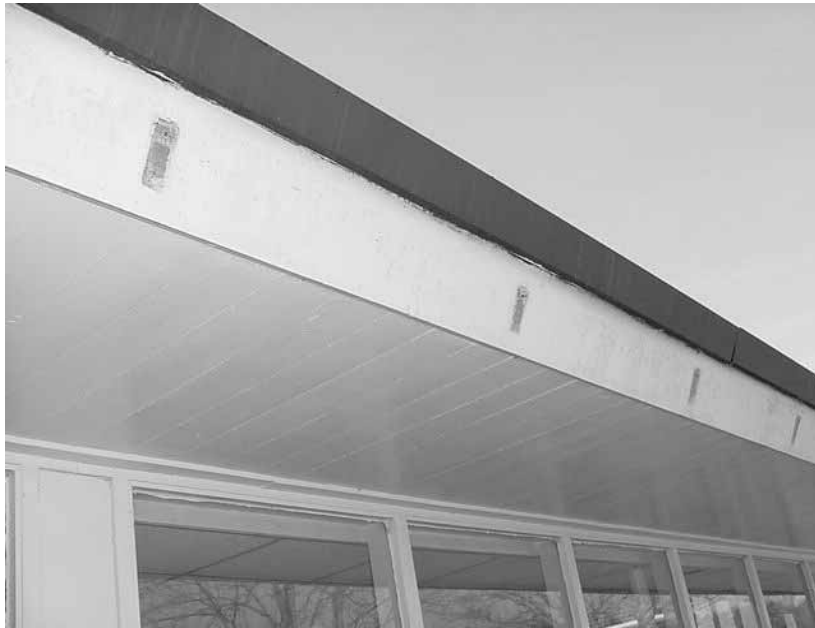
Picture 8

At the time of the assessment, the school was not equipped with a gutter/downspout system. It appears that the original gutter/downspout system was removed. Areas along the roof soffit had spots of dissimilar/missing paint and nail holes in an evenly spaced pattern that were likely where gutter brackets were located (Picture 8). In addition, drainage pipes in the tarmac, similar to downspout drains observed by BEHA staff at other schools, were seen at the corners of some MMES wings (Picture 9). Without downspouts/gutters, water accumulates along the exterior walls of the building,

Roof Soffit with Dissimilar/Missing Paint in an Evenly Spaced Pattern With Nail Holes, Which Is Likely the Location of the Gutter Brackets

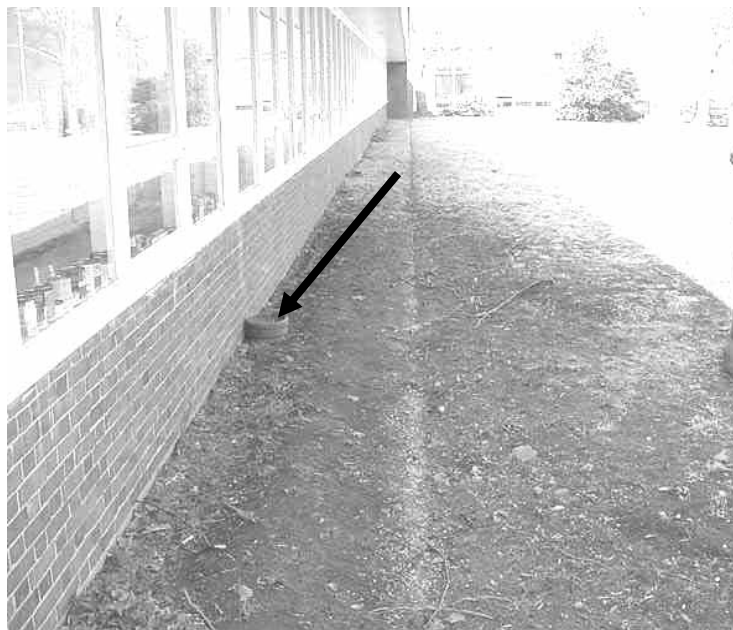
Picture 9

Pipes at Base of Wing That Formerly Drained Downspouts

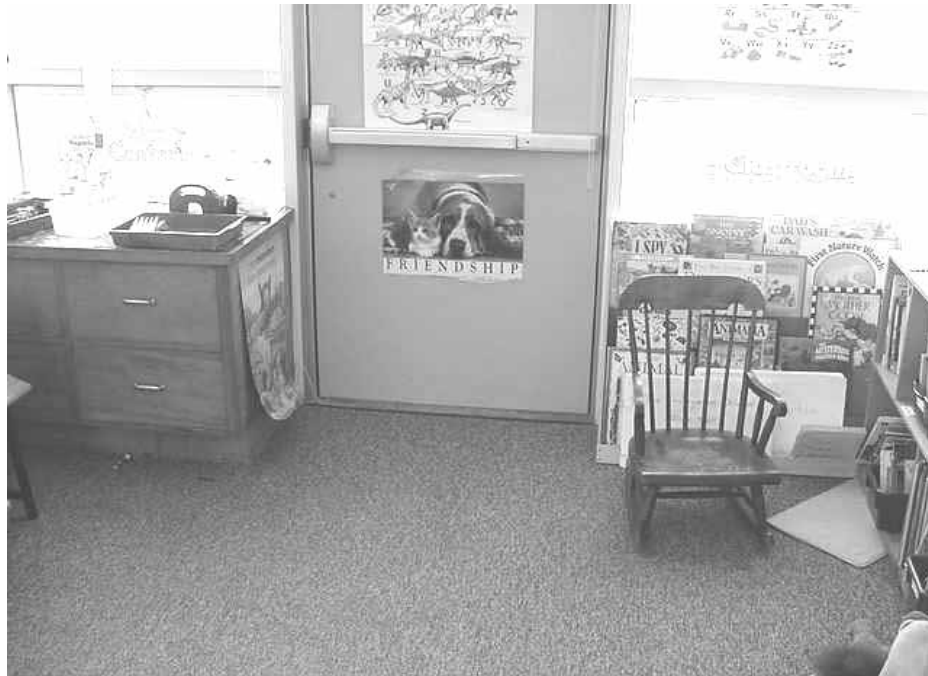
Picture 10

Of note was carpeting installed against the threshold of exterior doors in some classrooms (Picture 10). Wall-to-wall carpet installed around the threshold may become regularly moistened, typically during wind-driven rain or drifting snow. Roof/shelter systems that exist over exterior doors can also contribute to the moistening of carpet. Rainwater collecting on these shelters rolls off and collects at the base of the building. This design is problematic due to tarmac/cement slabs used as exterior door thresholds. Splashing rainwater can lead to chronic moistening of the exterior wall and doors, which in turn moistens carpet installed against the doorframe. Mold colonization of the carpet can occur from repeated moistening.

Carpeting Installed Against the Threshold of Exterior Doors

8. Remove carpeting up to three feet from the threshold of exterior doors. Replace carpeting with a non-slip, nonporous material (e.g., rubber matting, tile).

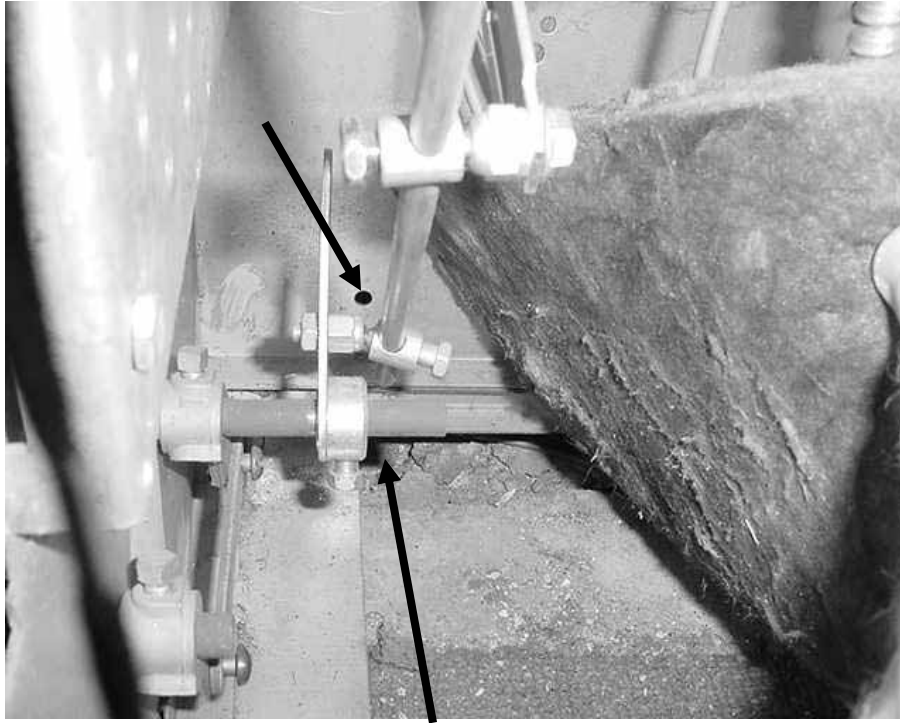
Picture 11

Several pathways exist for air in the wall space to migrate into occupied areas. A crawlspace located beneath classrooms functions as a chase-way for univent heating pipes. BEHA staff randomly examined a number of univent interiors. Spaces and holes were observed around pipes and within the air handling cabinets (Picture 11). Spaces were also noted in the rear wall of univent cabinets (Picture 12). The existence of these holes allows for air to by-pass the filters, resulting in aerosolization of materials (e.g., dust) to the classrooms. These breaches can also serve as pathways for air, odors and particulates to be drawn from exterior wall cavities into classrooms.

Spaces in Rear Wall of Air Handling Cabinet

11. Seal all holes in the walls at rear of univents as well as those in the univent air handling cabinets to limit filter bypass. Double sided, foil faced insulation with adhesive can be applied in a manner to create an airtight seal. Remove carpet from univent utility cabinets.

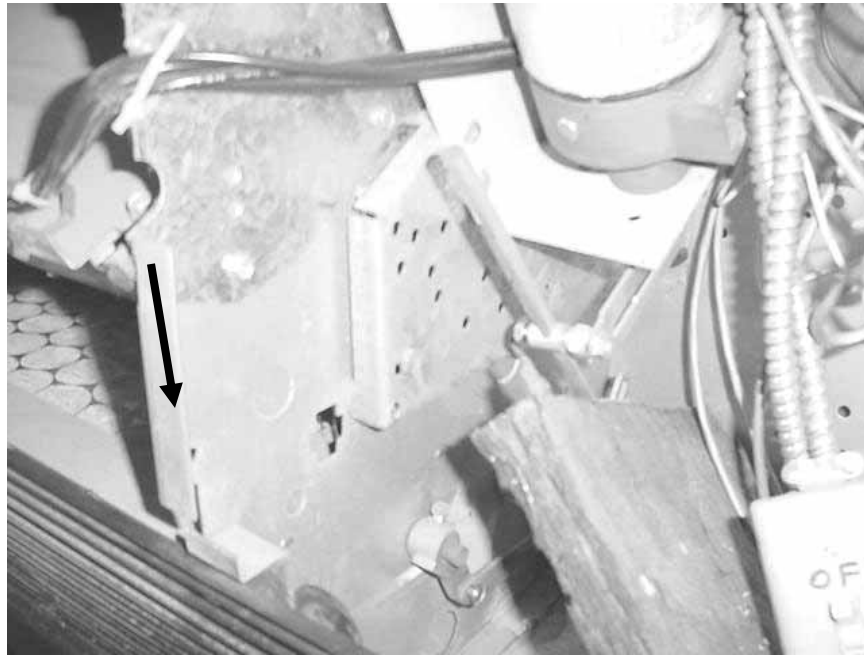
Picture 12

Hole in Wall of Univent Air Handling Cabinets

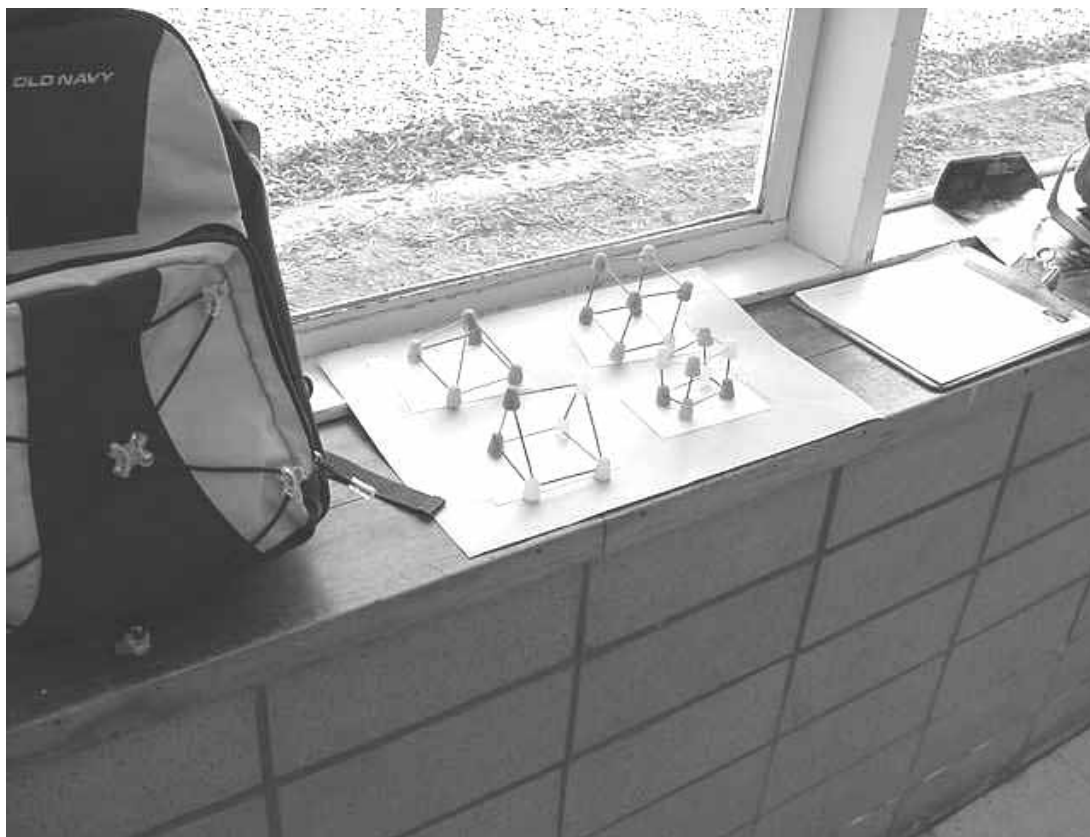
Picture 13

Of note was the use of food for student art projects (Picture 13). Exposed food products and reused food containers can attract a variety of pests. The presence of pests inside a building can produce conditions that can degrade indoor air quality. For example, rodent infestation can result in indoor air quality related symptoms due to materials in their wastes. Mouse urine is known to contain a protein that is a known sensitizer (US EPA, 1992). A sensitizer is a material that can produce symptoms in exposed individuals, including nose irritations and skin rashes. Pest attractants should be reduced/eliminated. Proper food storage is an integral component in maintaining indoor

Use of Food as Student Art Supplies

air quality. Food should be properly stored and clearly labeled. Reuse of food containers (e.g., for art projects) is not recommended since food residue adhering to the container surface may serve to attract pests.
